Manhole Inspection Summary

Manhole # S43AA_031MH

Record Plat: **43AA** Node: **031** Status: **Found**

Location Address: **811 n bond st**

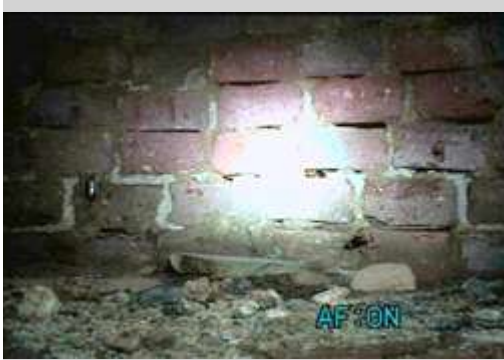
Misc

bench debris

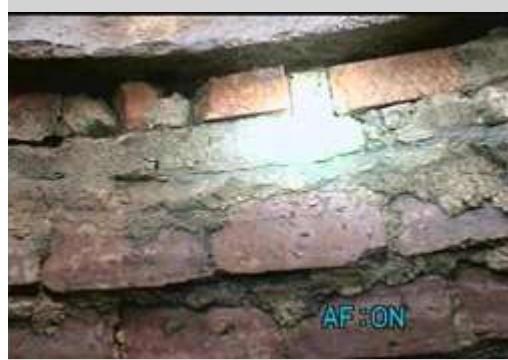
Defect 2

Condition: ☐ Sound ☒ **Cracked** ☐ Root Intrusion ☐ Loose Brick ☒ **Deteriorated**

chimney cracked deteriorated at frame joint

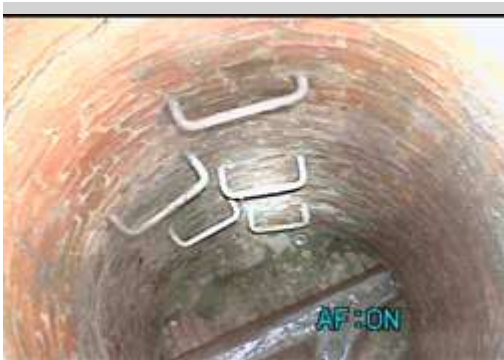
Defect 1

Count: **5** Missing: **0** ☒ **Corroded**

steps corroded
